Understanding the Impact of Mesh Tension on Vaginal Function and Structural Integrity

Katrina M. Knight,^{1,2} Sophya Breedlove,¹ Gabrielle E. King,² Pamela A. Moalli¹⁻³

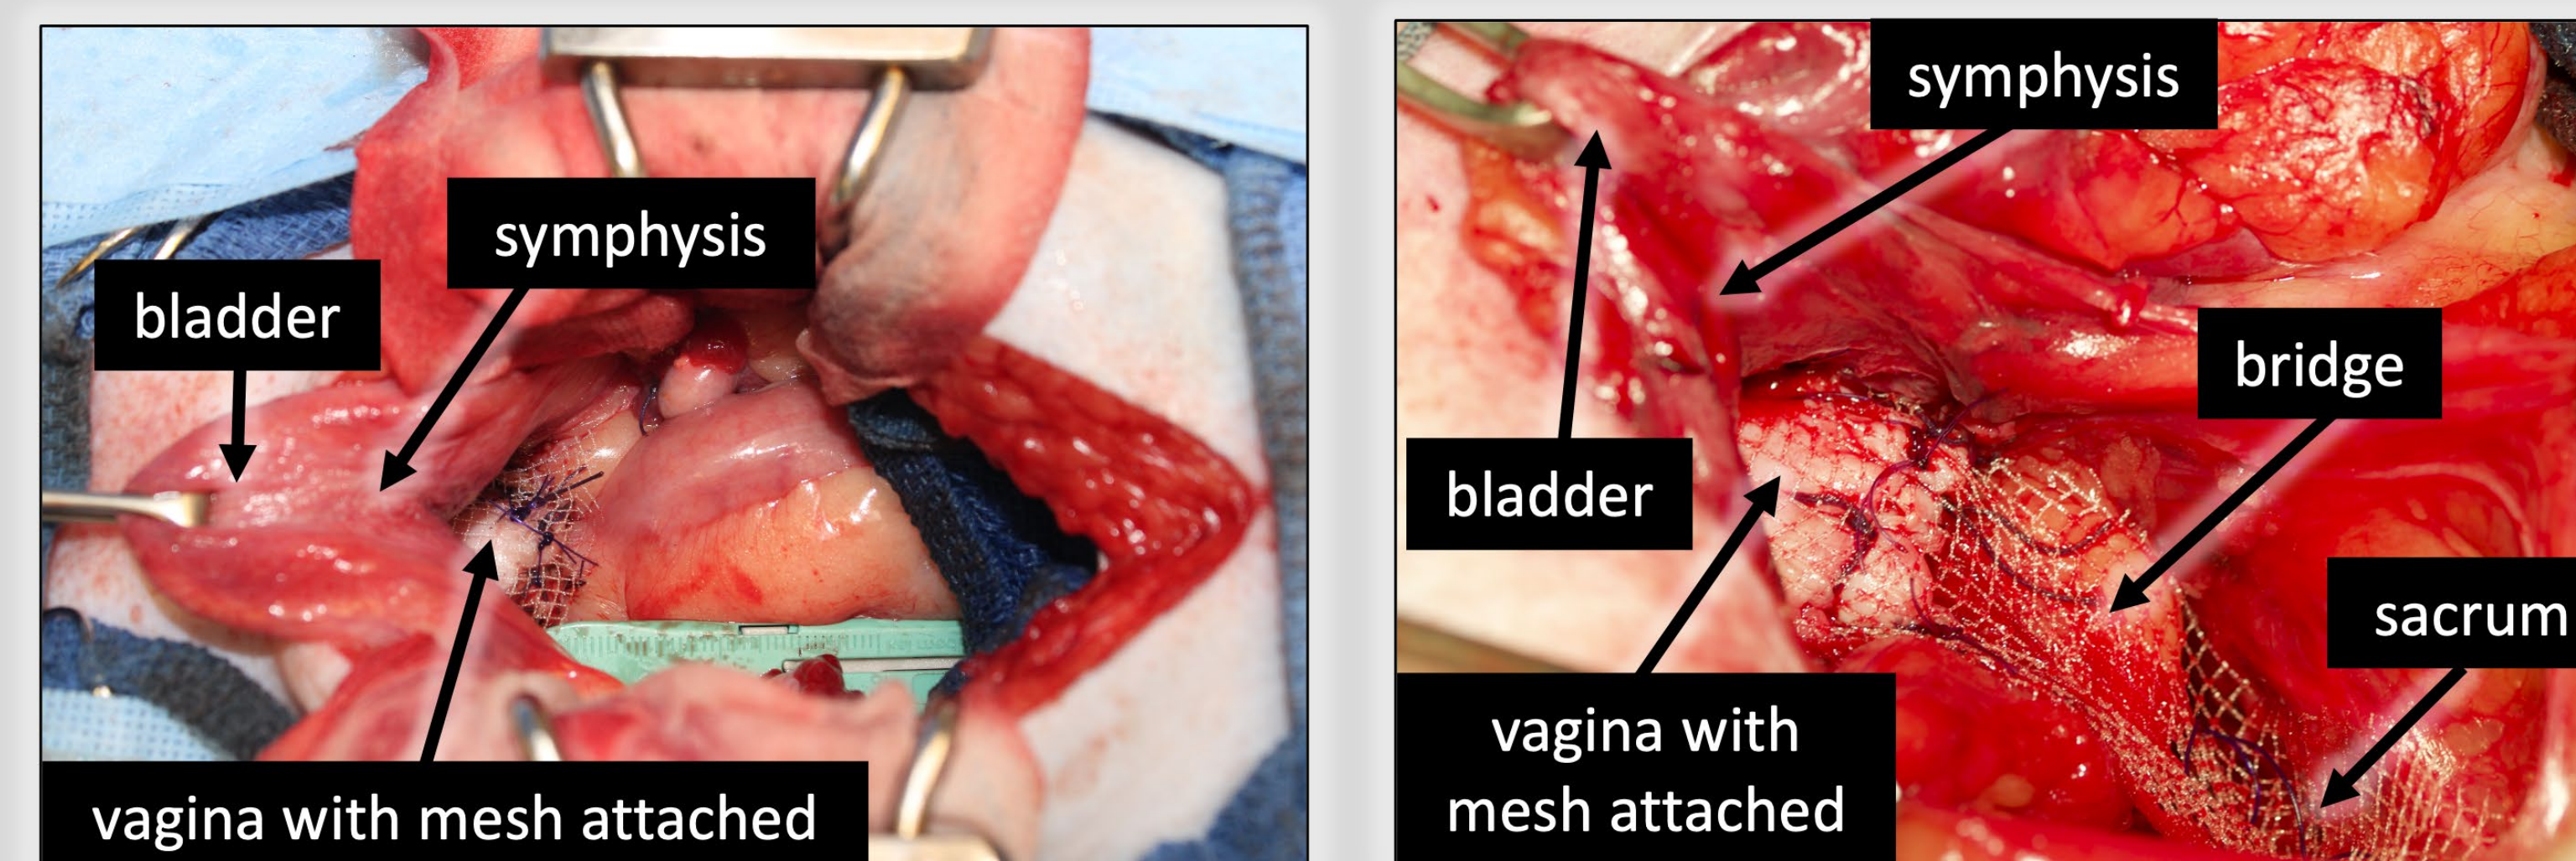
Figure 1: *In vivo* surgical images demonstrating mesh implanted (not deformed) onto the vagina in the absence of tension (left) and on low or high tension (right).

- Nonhuman primates, Rhesus macaques, aged 8 to 15 years old (IACUC 16088646)
- Mesh was implanted onto the vagina via sacrocolpopexy (Figure 1)
 - No Tension (n=9)
 - Low Tension (1 N, ~0.4 lbs, n=8)
 - High Tension (10 N, ~2.2 lbs, n=8)
- Sham (no mesh implanted) served as controls (n=9)
- After 12 weeks, vagina (Sham) and mesh-vagina complexes excised *en bloc*

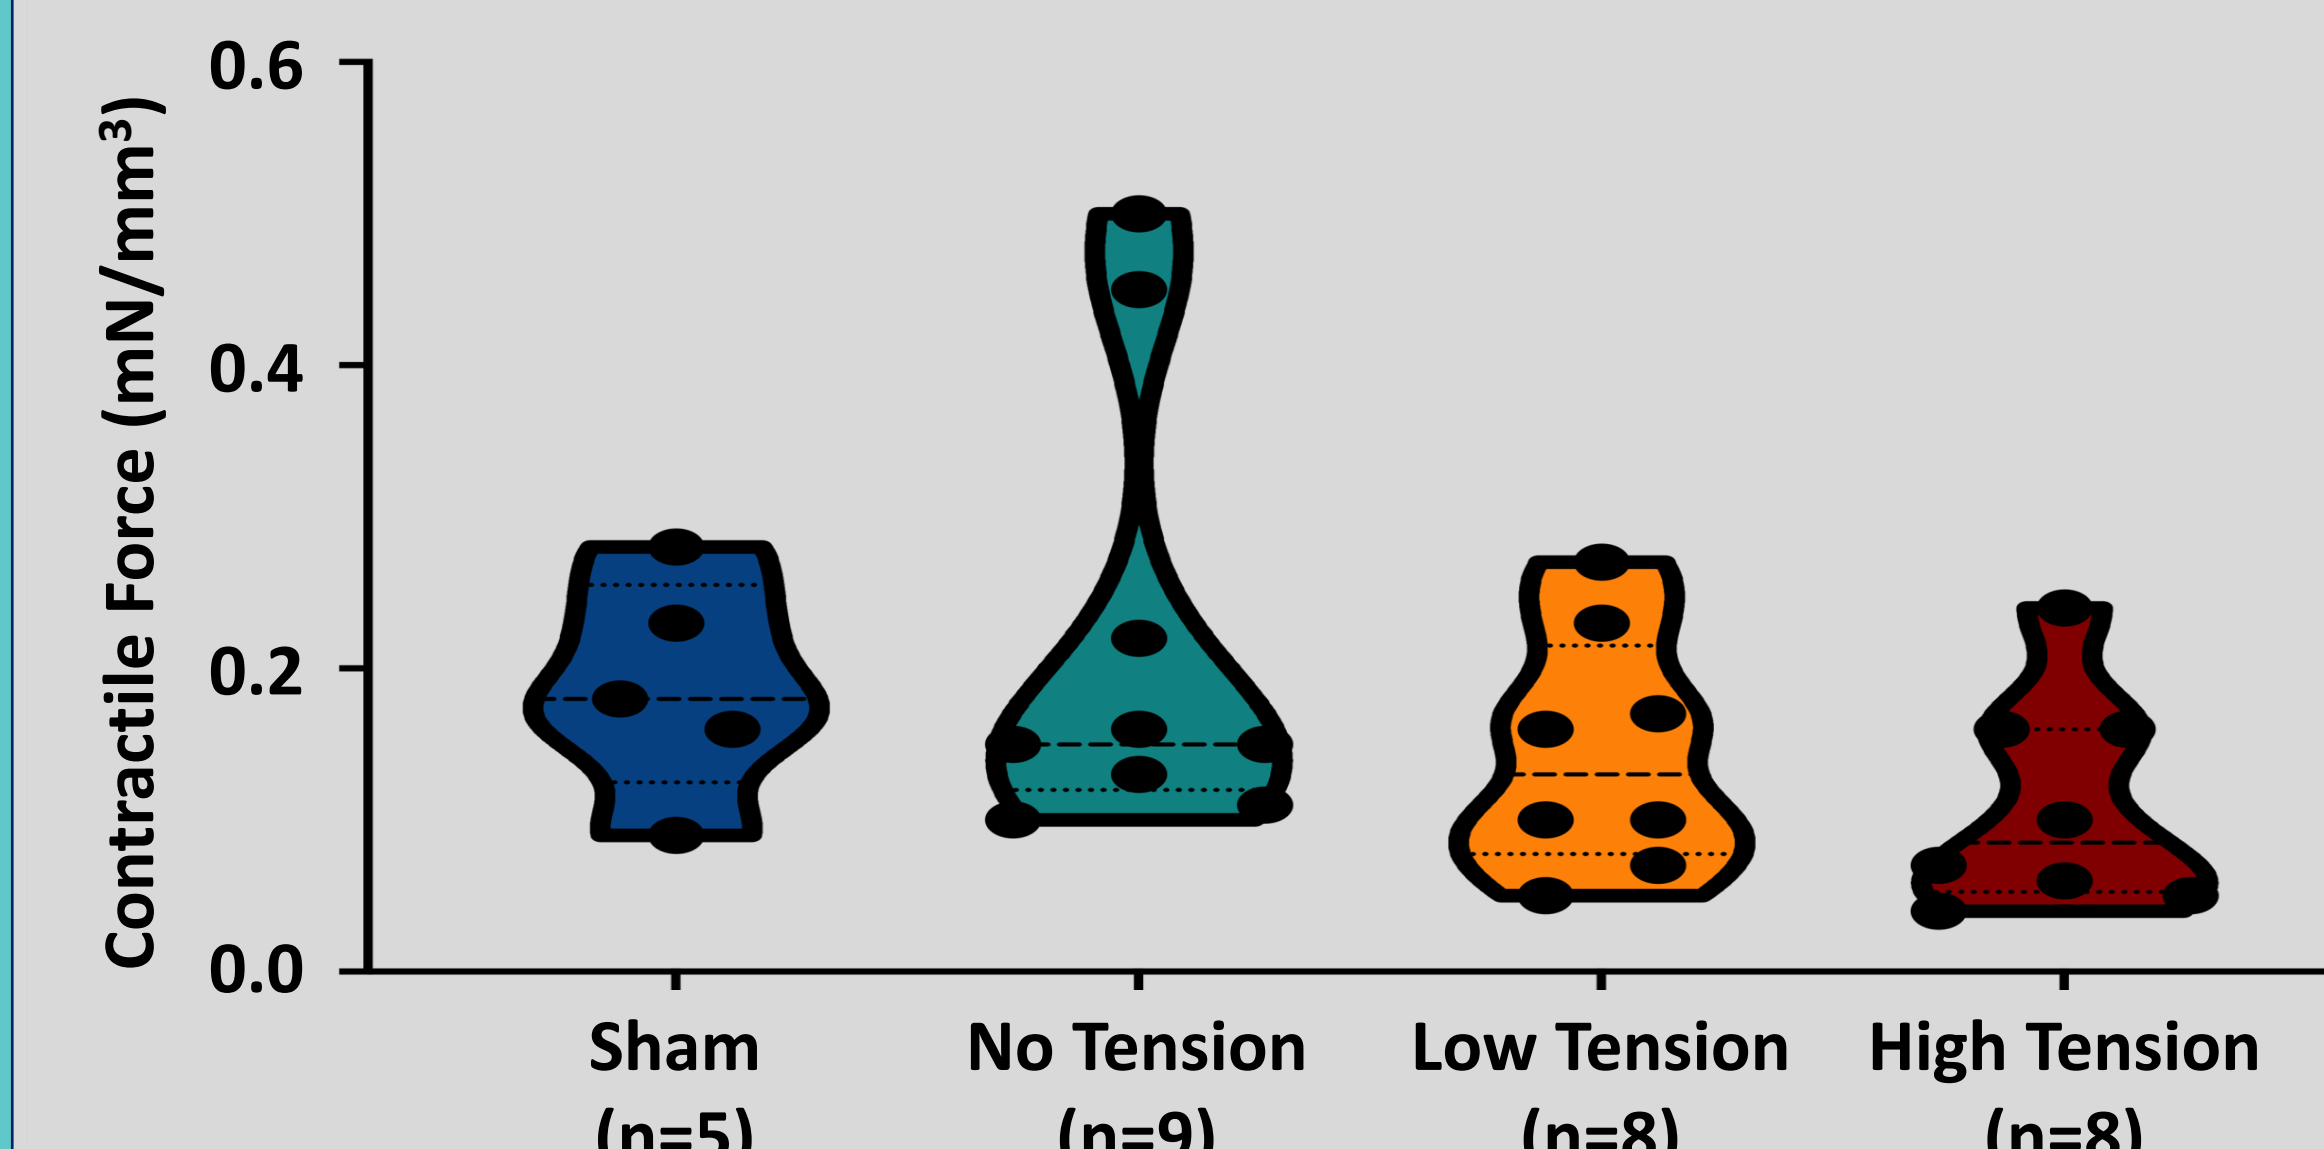
Figure 4: A trend towards a decrease in contractility was observed with increasing tension; however, vaginal contractility was not significantly different between the groups ($p=0.174$).

- Increasing mesh tension had minimal impact on the contractile function and structural integrity of the vagina
 - Difference between low and high tension may be too small to observe differences
 - Inherent biological differences between primates within a group may have impacted the results
- Increased sample size and future studies assessing histologic and biochemical endpoints are needed to further investigate study findings

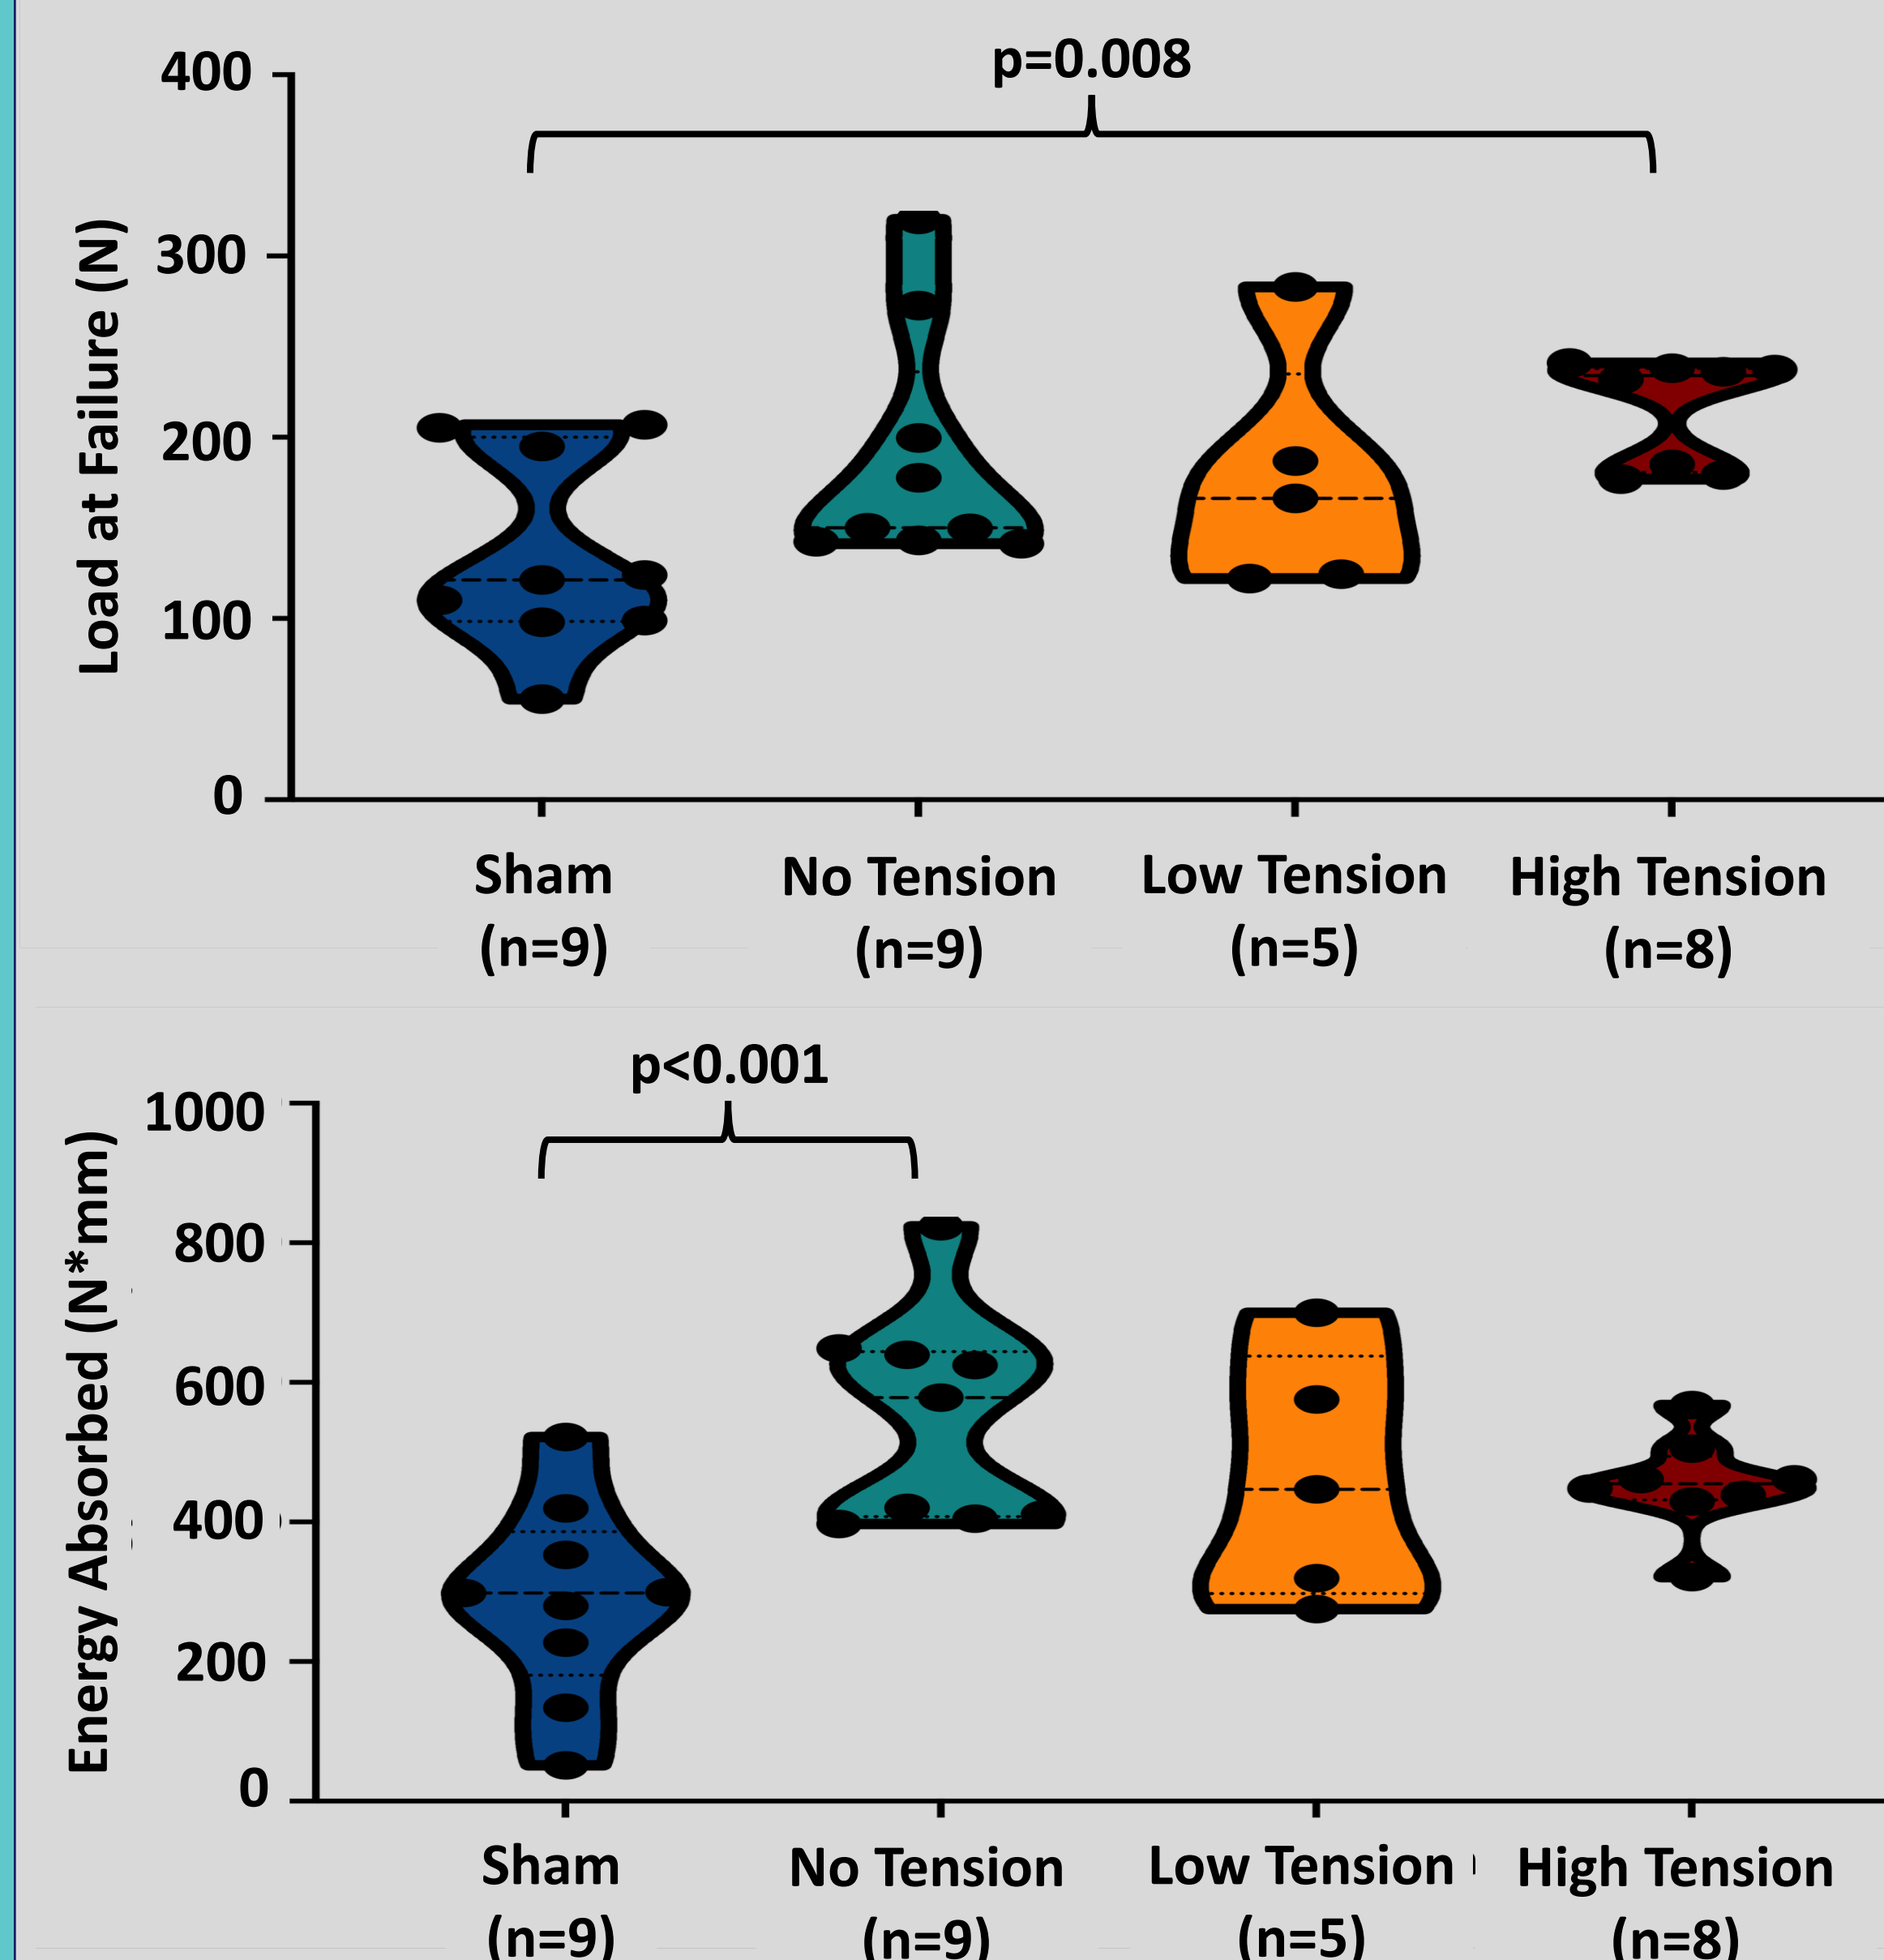
Figure 5: Compared to Sham, the load at failure was 60% higher for High Tension ($p=0.008$) while the energy absorbed was 91% higher for No Tension ($p<0.001$). All other structural properties (i.e., stiffness and elongation at failure) were not significantly different ($p>0.05$).
